# Vintage on the Bluffs HOA

## Level I Reserve Study

**Client Reference Number ..... 11034**  
**Property Type ..... Condominiums**  
**Number of Units ..... 184**  
**Fiscal Year End..... December 31**

**Date of Property Inspection ..... January 18th, 2008**  
**Inspector ..... Robert Forney**

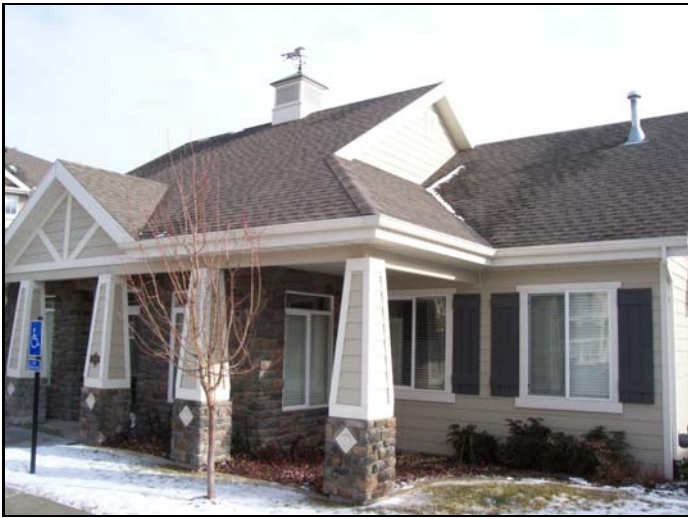
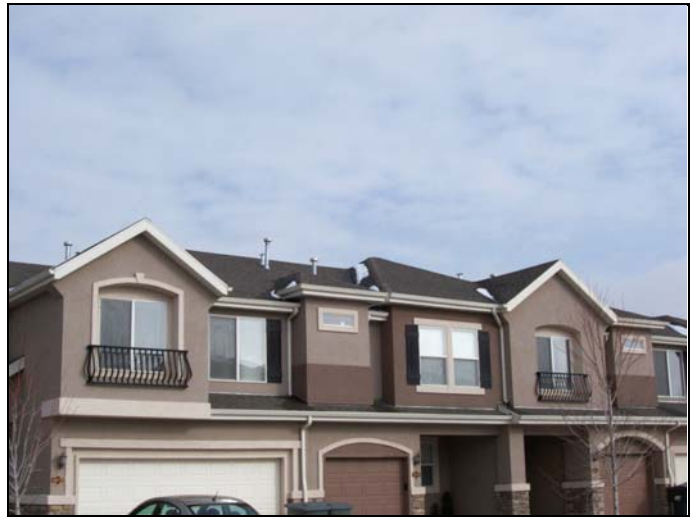
Comp #: 105 Pitched Roof - Comp Shingle - Replace

All shingles are intact and in good condition with no problems noted at time of inspection. Typically this type of roofing material has a useful life of approximately 18 years. Inspect roofs regularly and make local repairs as necessary as an operating issue to ensure full life from this component. Remaining life based on current age and condition.

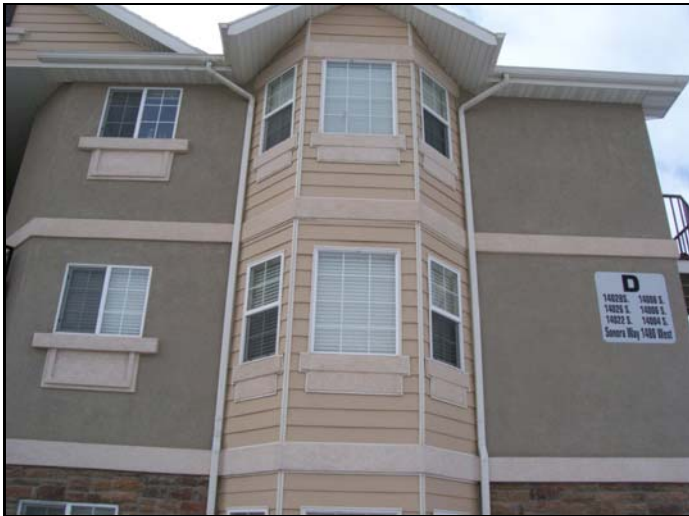
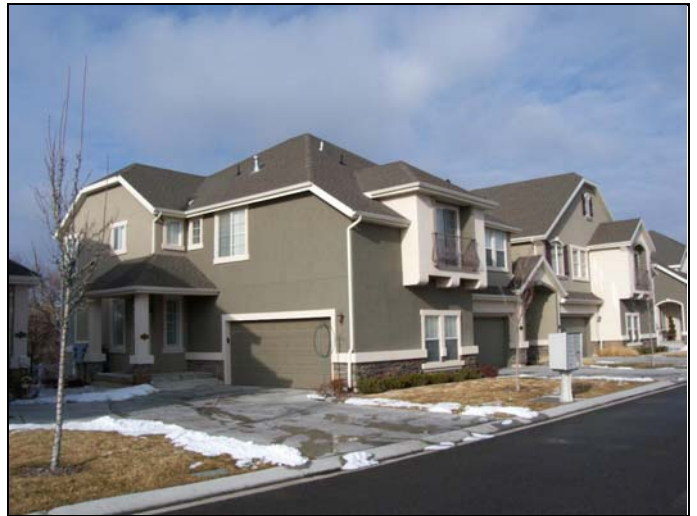
## Comp #: 201 Buildings - Repaint

Painted stucco surfaces are generally in good condition, no significant staining or discoloration noted. We recommend painting these surfaces approximately every 8 to 10 years to maintain appearance. Remaining life based on current condition.

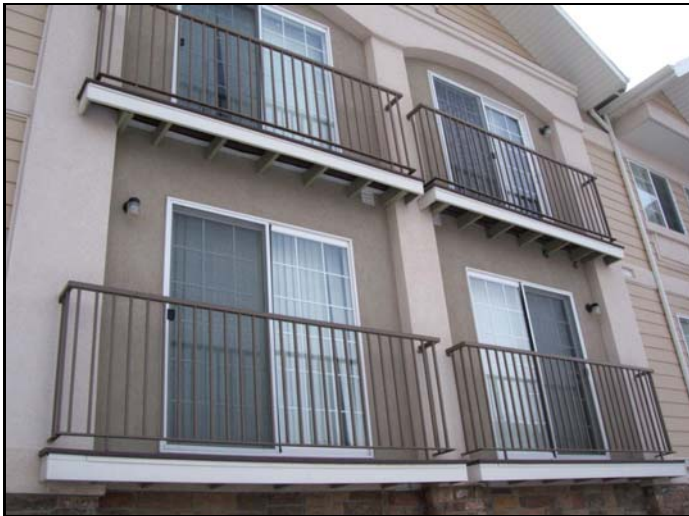
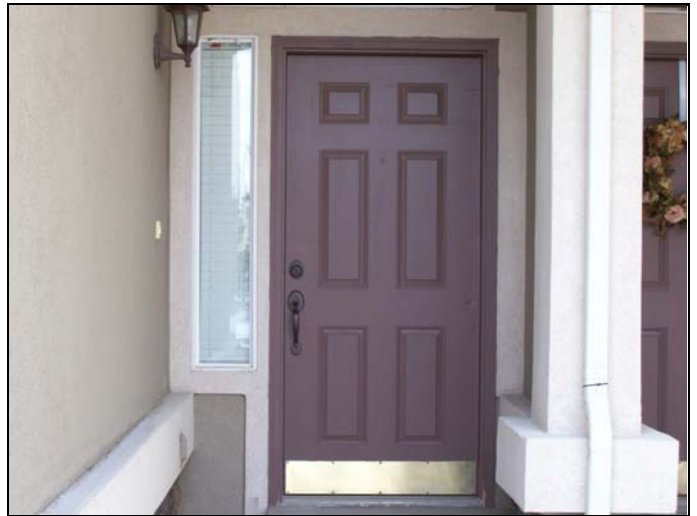
Comp #: 202 Building Trim - Repaint

Trim surfaces are generally in good to fair condition. No significant rusting noted on railings, no fading or discoloration on siding or front doors. Repaint these surfaces approximately every 4 to 6 years to maintain appearance and protect metal. Remaining life based on current age and condition.

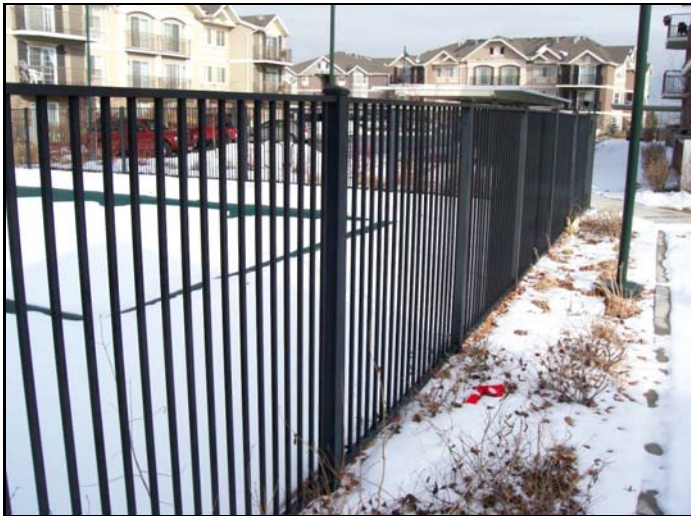
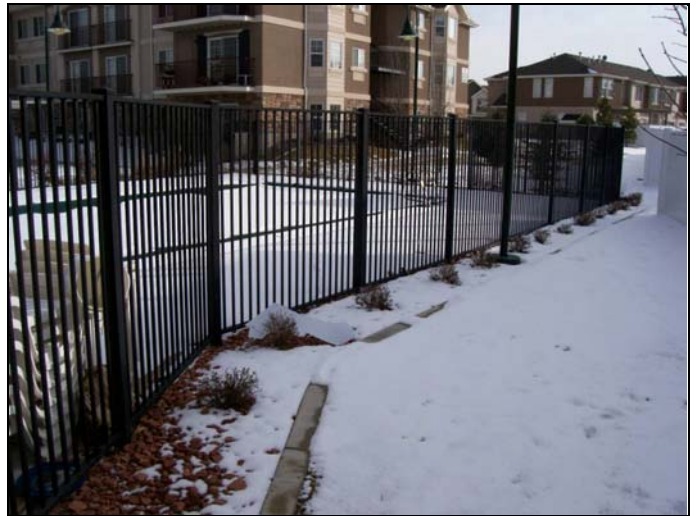
Comp #: 207 Wrought Iron Fencing - Repaint

Painted wrought iron surfaces are in good to fair condition, no rusting or broken welds noted. Repaint this component approximately every 5 years to maintain appearance and protect metal surfaces. Remaining life based on current condition.

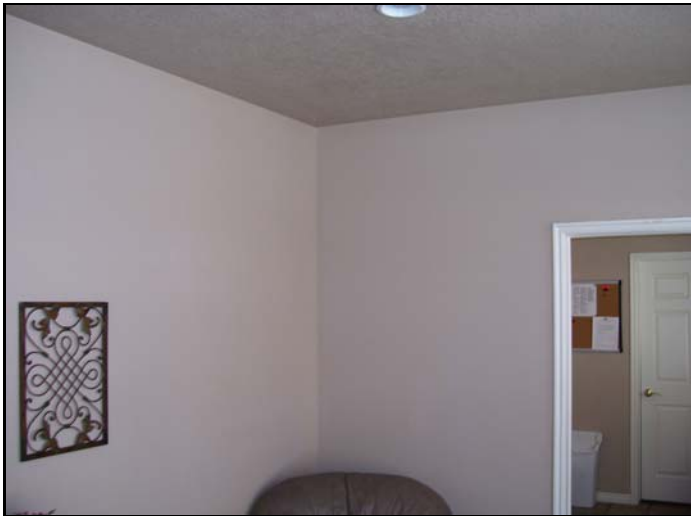
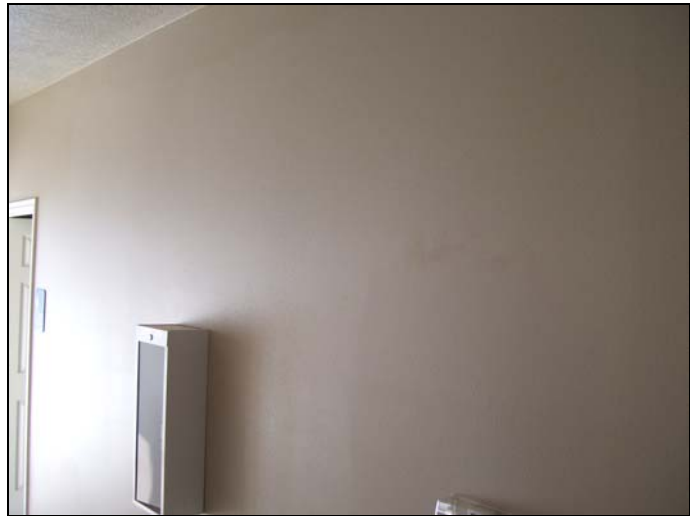
## Comp #: 216 Interior Surfaces - Repaint

Interior painted surfaces are in fair condition. Some local marking noted but no significant appearance concerns observed. Expect to repaint these surfaces approximately every 10 years to maintain appearance.

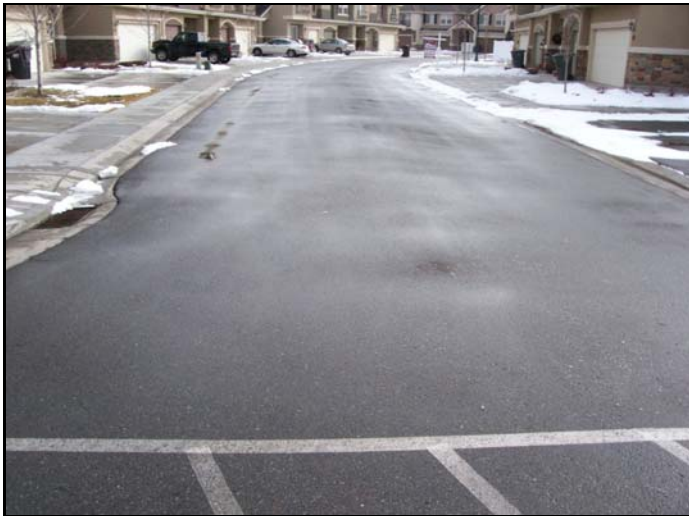
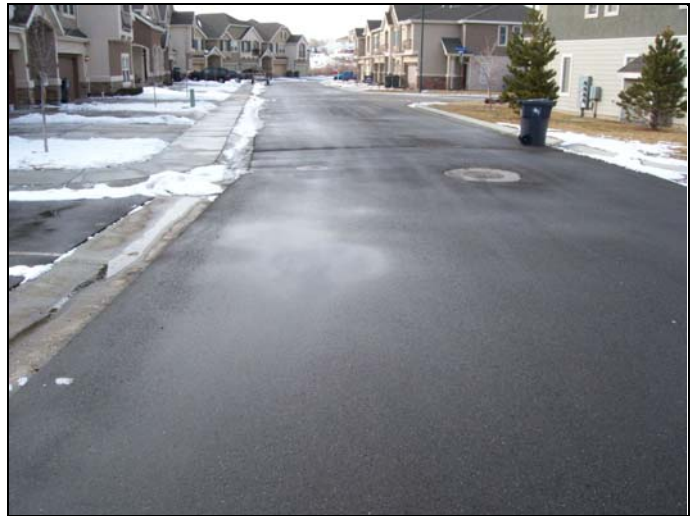
Comp #: 401 Asphalt - Overlay

Asphalt streets are in good condition. No cracking or structural problems noted at the time of inspection. Seal these streets regularly (see Comp# 402 Asphalt - Slurry Seal) to protect surface and ensure full life.

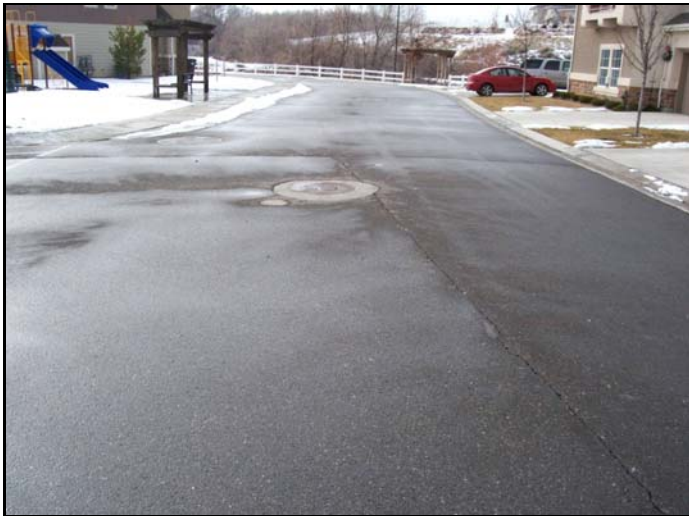
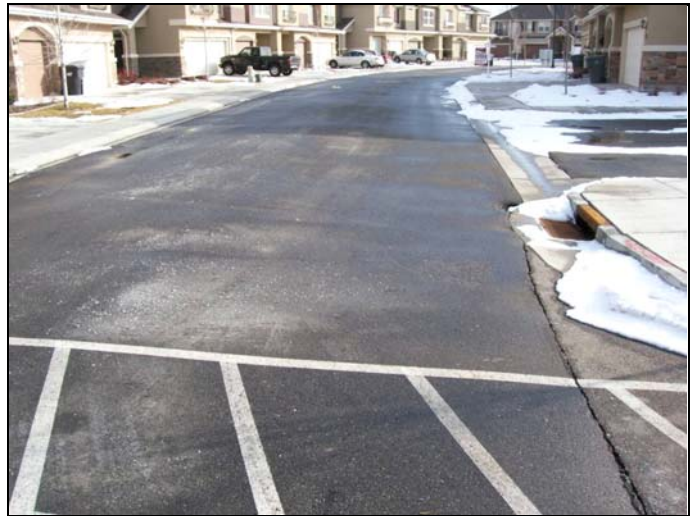
Comp #: 402 Asphalt - Slurry Seal

Asphalt seal coat is in good to fair condition. Some drying noted but no significant cracking observed. Seal asphalt surfaces regularly to prevent premature overlay (see Comp# 401 Asphalt - Overlay). Remaining life based on current condition.

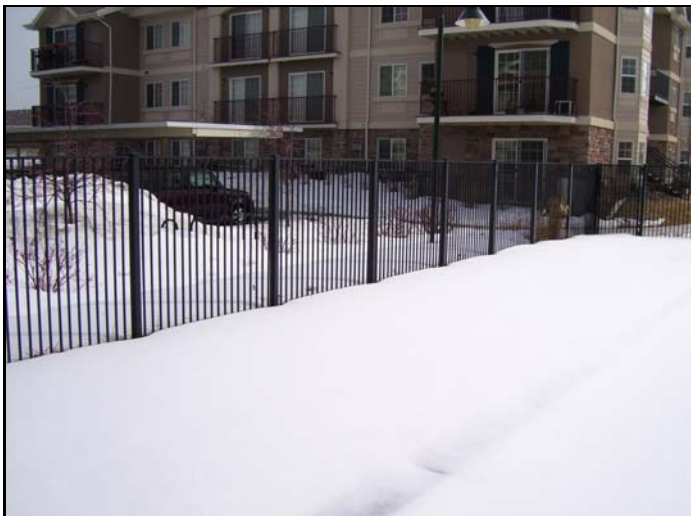
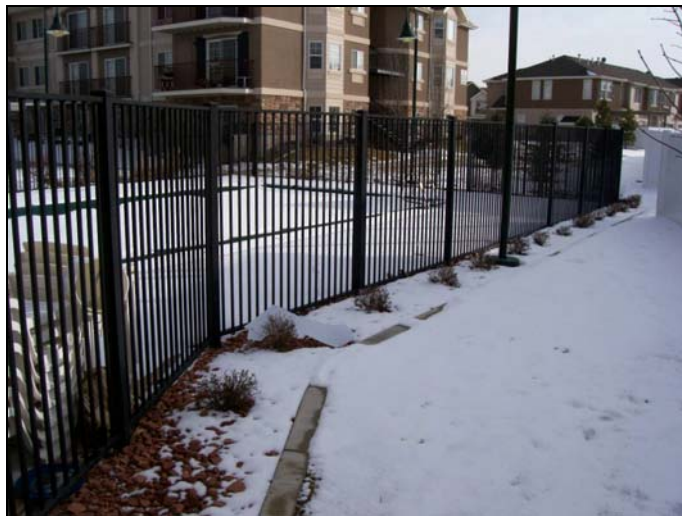
Comp #: 1002 Wrought Iron Fencing - Replace

Fencing is in good condition. No significant rusting or structural problems noted at the time of inspection. With regular painting and maintenance, expect a useful life of 20 to 25 years from this component. Remaining life based on current age.

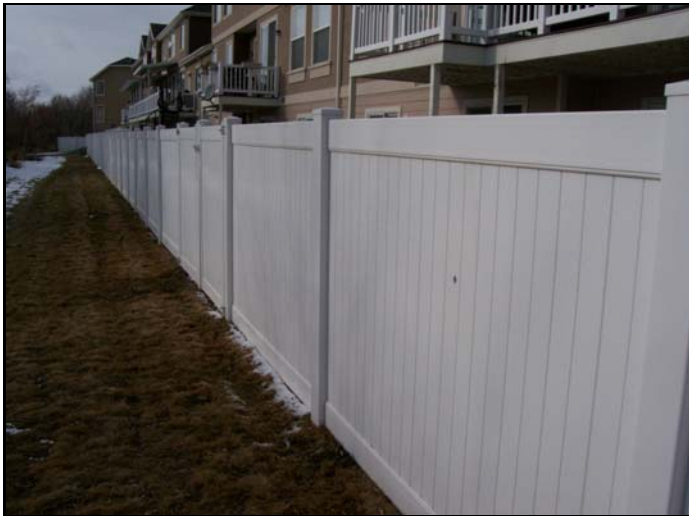
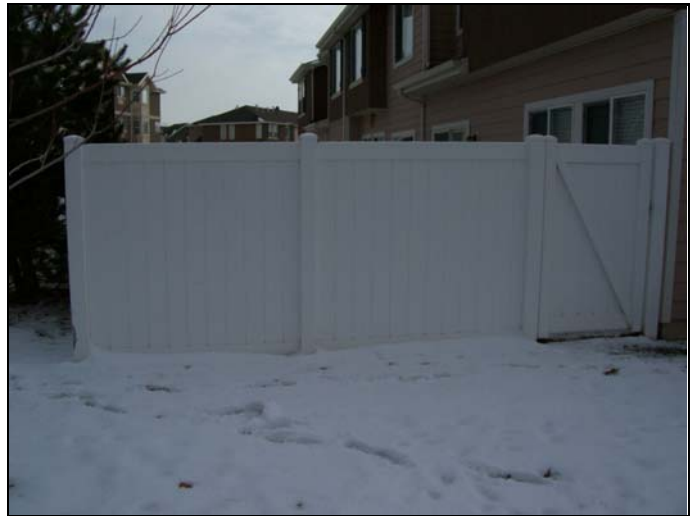
## Comp #: 1008 PVC Vinyl Fencing - Replace

Fencing was observed to be in good condition at the time of inspection. Some minor warping noted in local areas, noted two missing rails at fencing north of Cabernet Drive. We recommend making local repairs as necessary as an operating expense and funding to completely replace this fencing on an 18-year schedule. Remaining life based on current age.

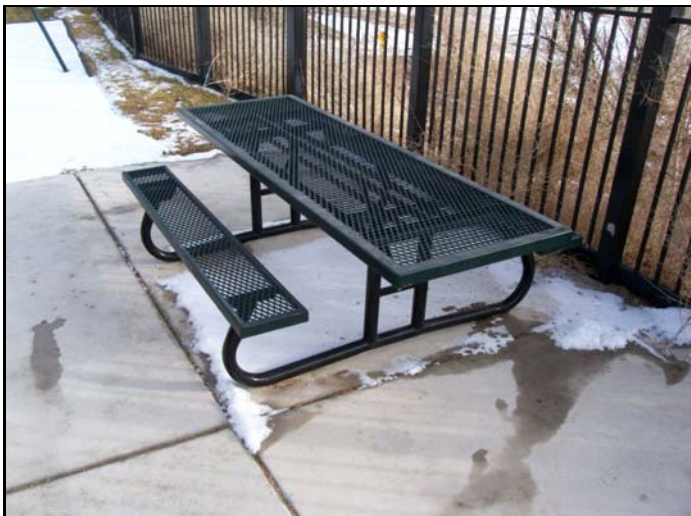
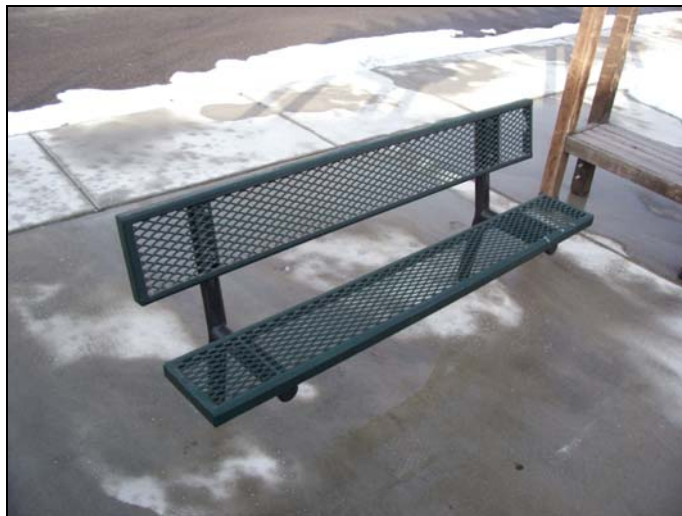
Comp #: 1306 Park Furniture - Replace

Due to the minia quantity of furniture we recommend replacing these items individually as an operating expense. No reserve funding necessary.

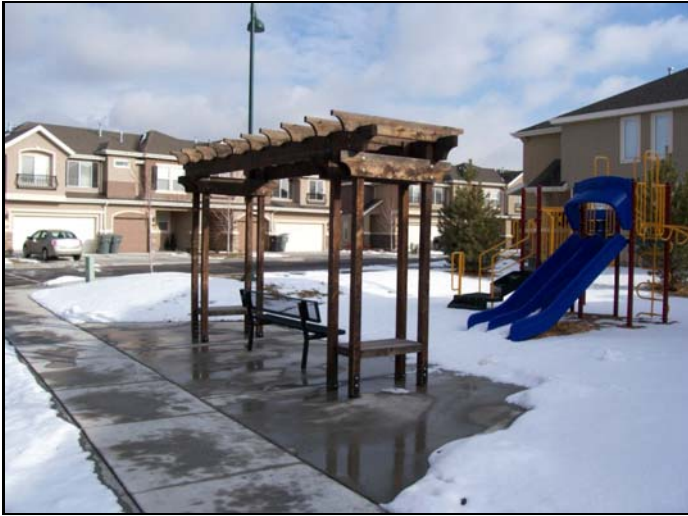
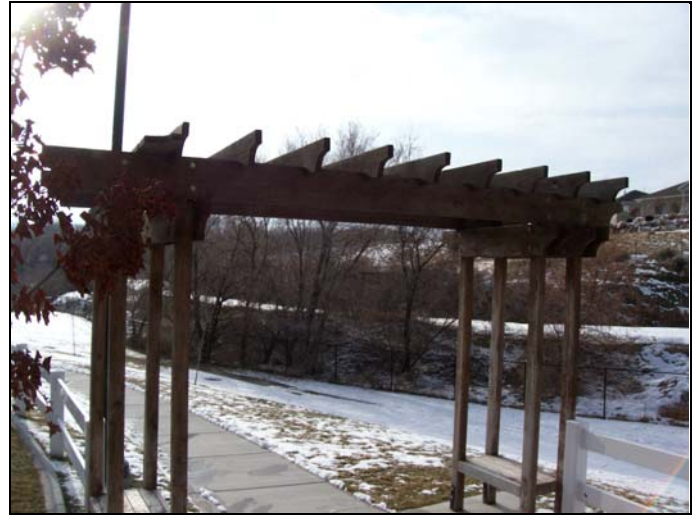
Comp #: 1309 Wood Trellis - Replace

Structures are in good condition. We recommend funding to replace these structures approximately every 18 years to ensure appearance.

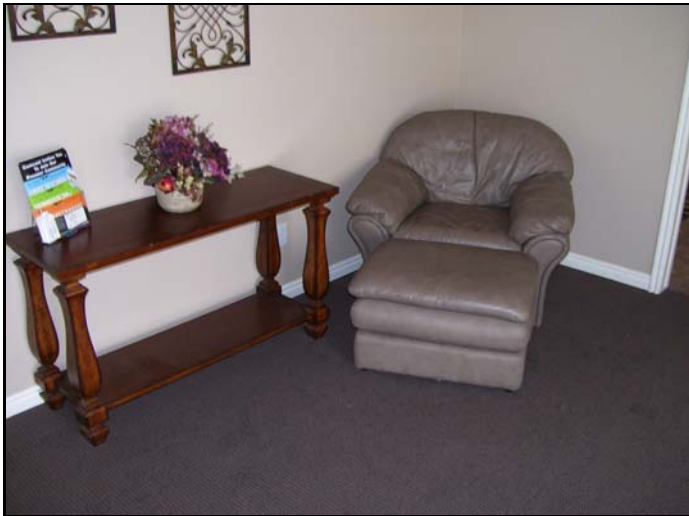
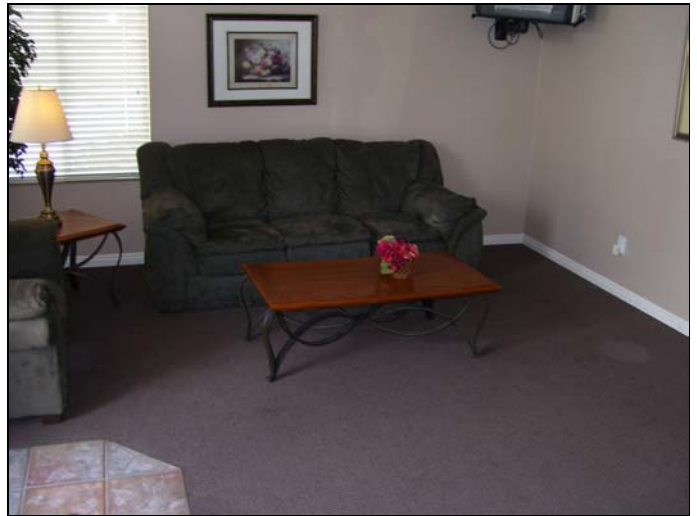
Comp #: 1405 Furniture - Replace

Furniture is generally in good to fair condition. No significant signs of wear or appearance concerns noted at the time of inspection. Reserve to make significant replacements to furniture approximately every 10 years to maintain appearance and keep up with decorative tastes.

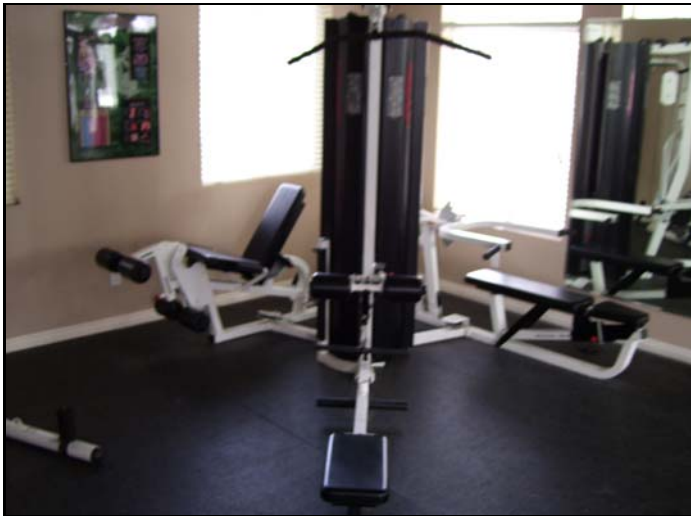
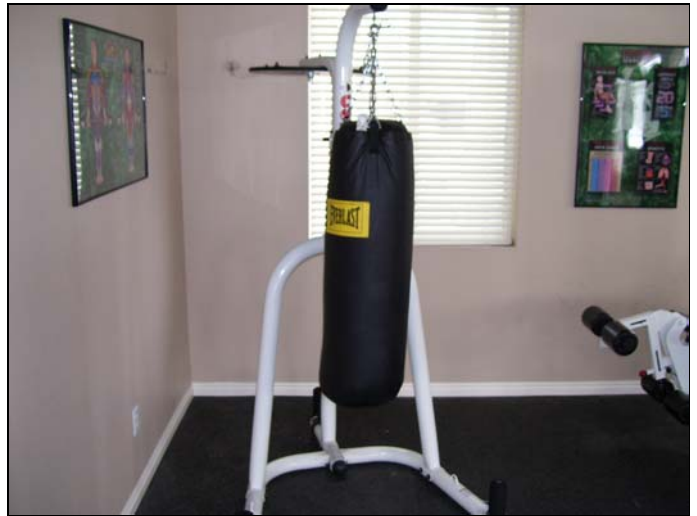
Comp #: 1406 Fitness Equipment - Replace

Universal machine is in good condition. No rips or tears in upholstery, no broken cables observed. We recommend replacing the heavy bag as necessary as an operating expense and funding to completely replace universal machine and bag stand every 15 years.

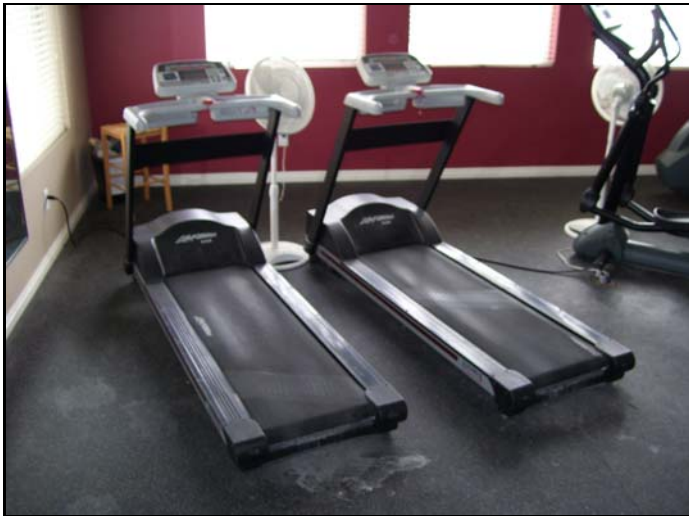
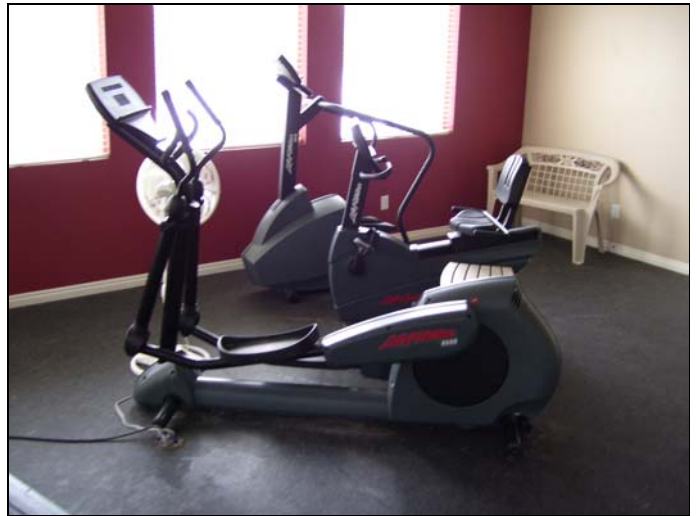
Comp #: 1407 Cardio Equipment - Replace

Cardio fitness equipment is in fair condition. No evidence of advanced wear or damage but equipment is generally older. Due to higher use and wear expect to replace this equipment approximately every 7 years.

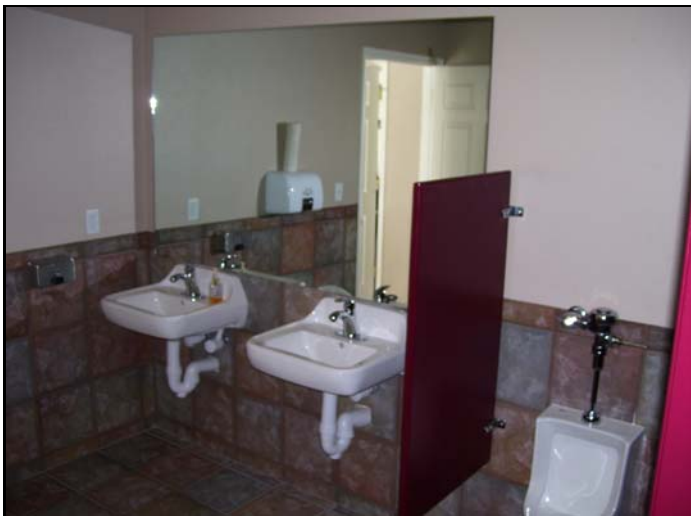
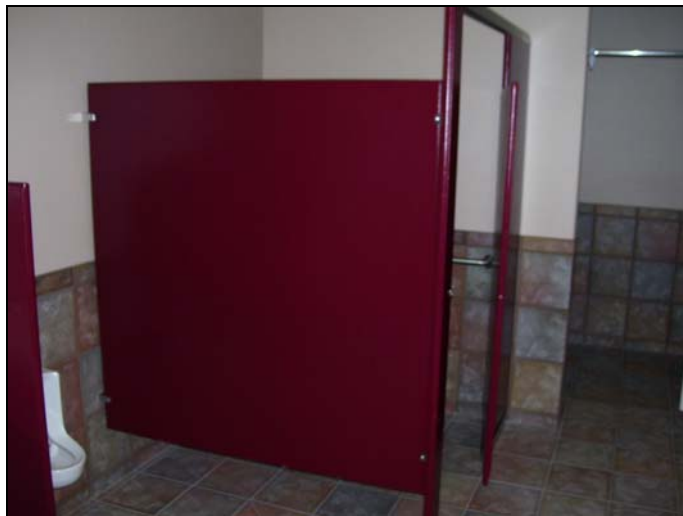
## Comp #: 1413 Restrooms - Remodel

Restrooms are in good condition. No appearance concerns noted at the time of inspection. We recommend funding to generally remodel and refurbish these restrooms approximately every 16 years to maintain appearance and keep up with current decorative tastes.

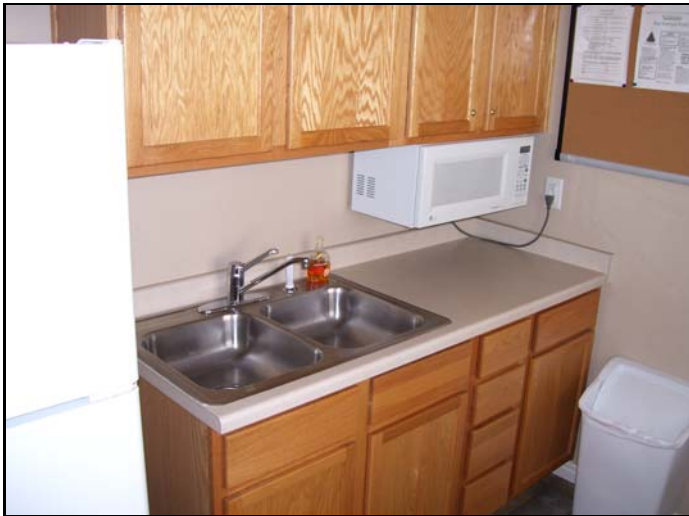
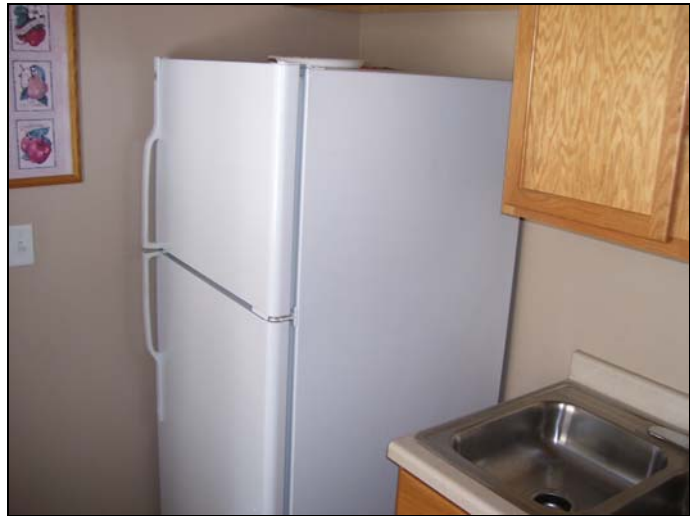
## Comp #: 1417 Kitchen - Remodel

Kitchen is in good condition. No signs of wear or appearance concerns noted. Expect to remodel kitchen approximately every 18 years to keep up with current decorative tastes and ensure proper function of appliances. Remaining life based on current age and condition.

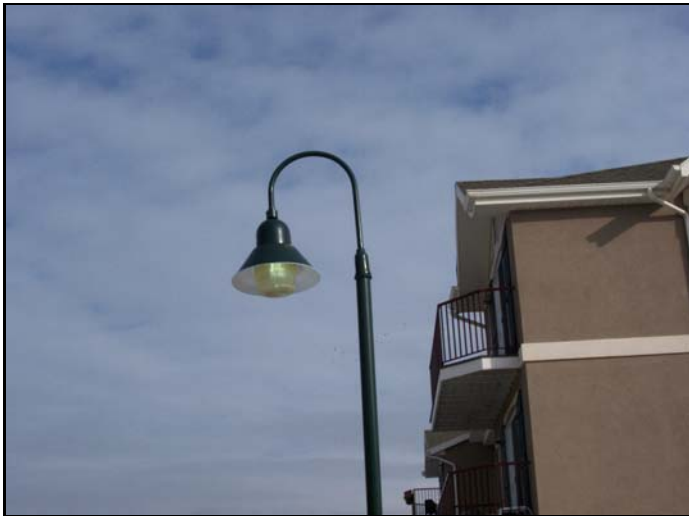
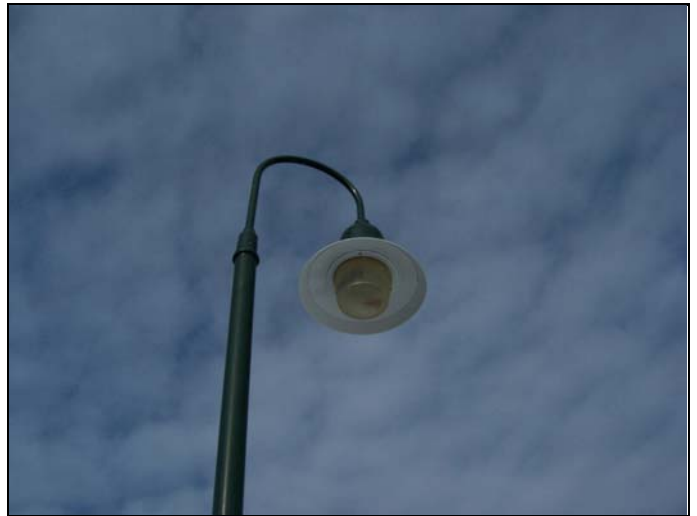
## Comp #: 1604 Pole Light Fixtures - Replace

No structural problems noted with lights at the time of inspection. Although the poles should reach an extended life we recommend funding to replace the pole light fixtures approximately every 18 years.
